INVESTIGATION OF MASS PLACEMENT OF
SAND ASPHALT FOR UNDERWATER PROTECTION
OF RIVER BANKS

TECHNICAL MEMORANDUM NO. 3-329

WATERWAYS EXPERIMENT STATION

AUGUST 1951

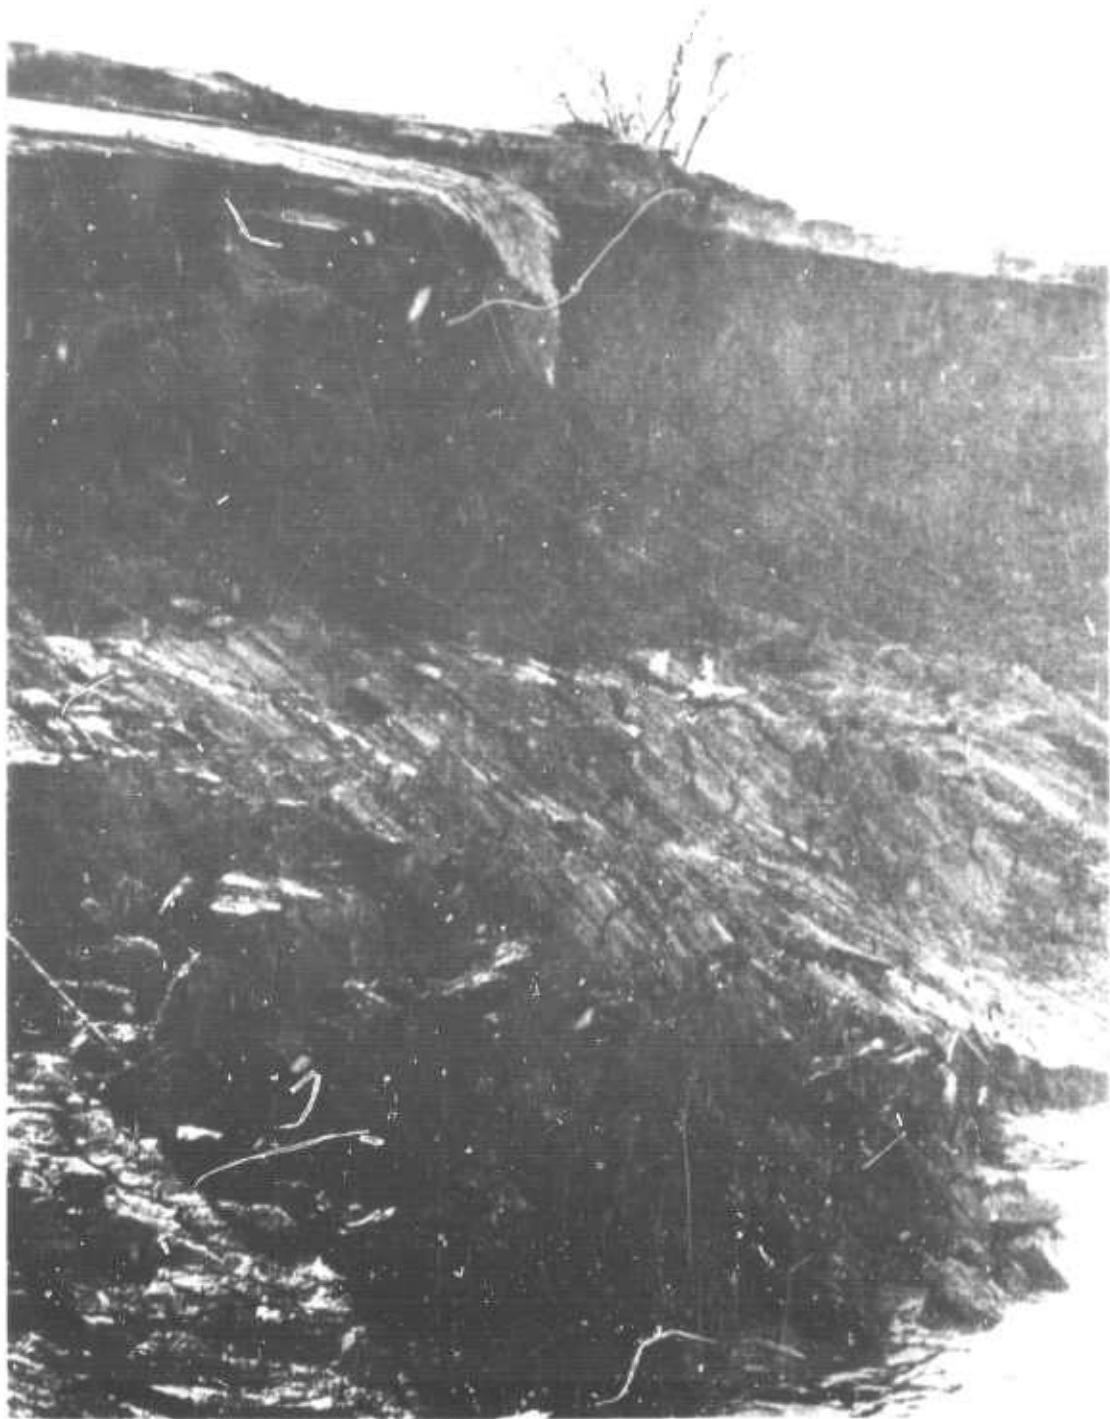
Photograph 39. Sand-asphalt spur dikes (arrows) placed under water on unrevetted bank at upper end of False Point revetment in 1948 and rehabilitated by mass underwater placement of 20% asphalt cement mixture in 1949.
